## Maraetōtara river quality trends

### Milestone: Complete detailed 5-year review of water quality trend data

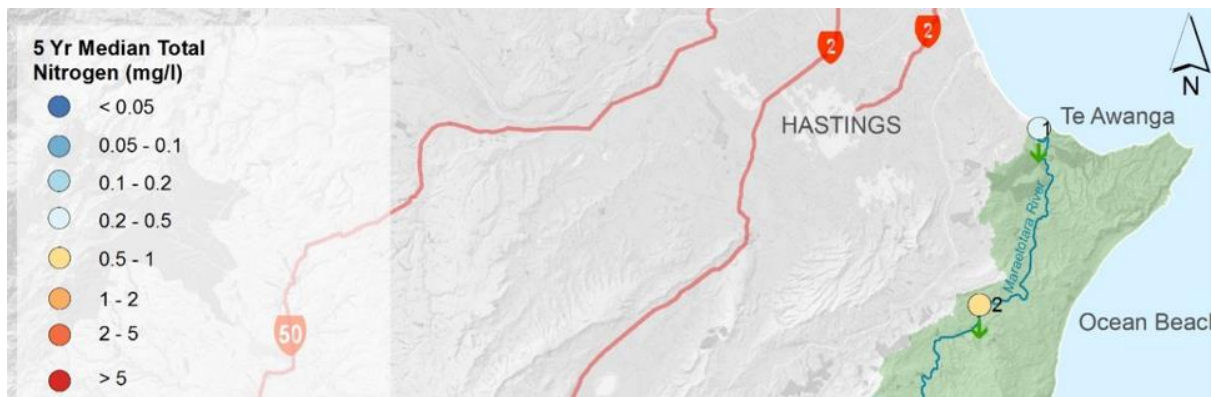
5 year median and trends in total nitrogen (TN) concentrations

Maraetōtara River (at Te Awanga) (0.43mg/l) had the lowest median TN concentrations of all 8 sites, and were largely better than the lowland ANZECC trigger value.

The Maraetōtara River (at Waimarama Rd) (0.87mg/L) had elevated median TN concentrations.

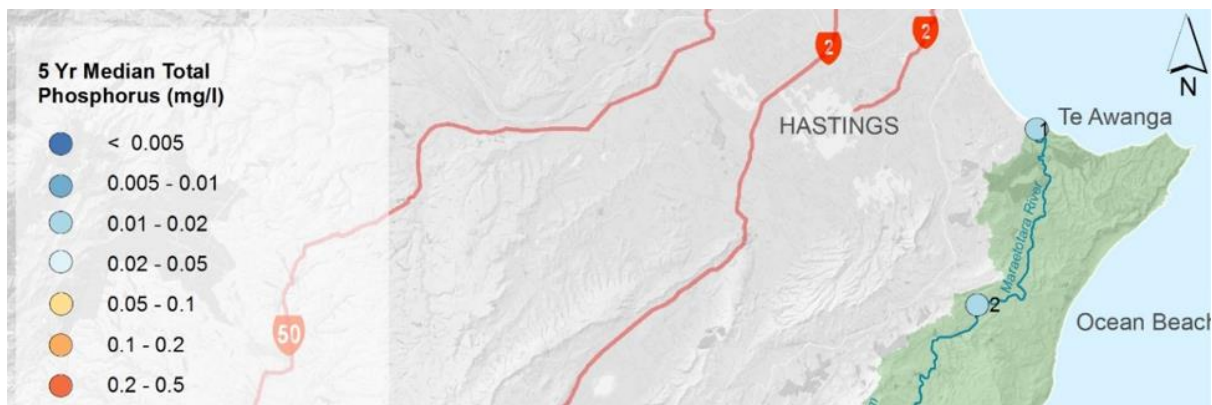
5 year median total phosphorus (TP) concentrations at SOE monitoring sites

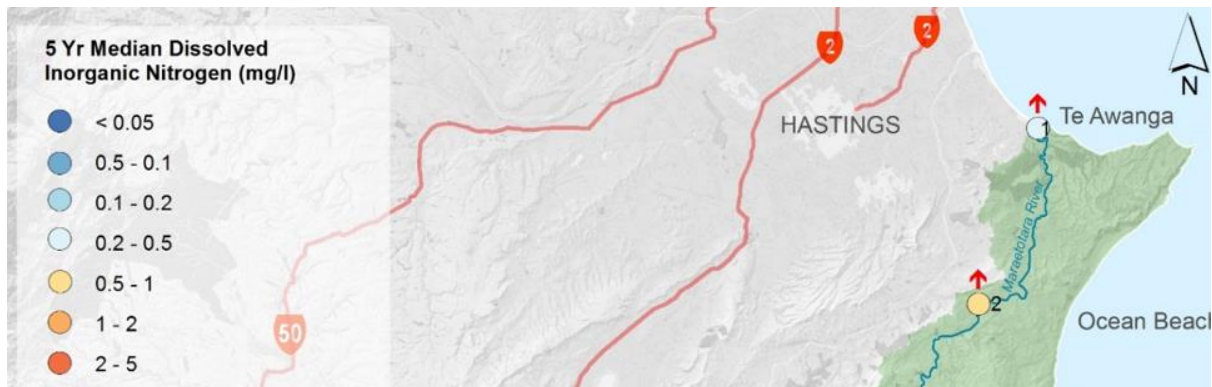
5 year median and trends in dissolved inorganic nitrogen (DIN) concentrations at SOE monitoring sites

Dissolved inorganic nitrogen (DIN) and dissolved reactive phosphorus (DRP) concentrations were also examined at SOE monitoring sites. The Maraetōtara (at Te Awanga) and the Pouhokio Stream were more elevated, but still fell into the 'B' state. The median DIN concentrations for the Maraetōtara River at Waimarama Rd was more than twice that of the Te Awanga site, and fell into the 'C' band. The lower

concentration at the downstream sites suggests DIN is being attenuated by macrophyte and periphyton communities.

DIN concentrations decreased (improved) at the Maraetōtara River (at Te Awanga) (5.99%). Both sites on the Maraetōtara River fell into the 'B' band showing slight enrichment.

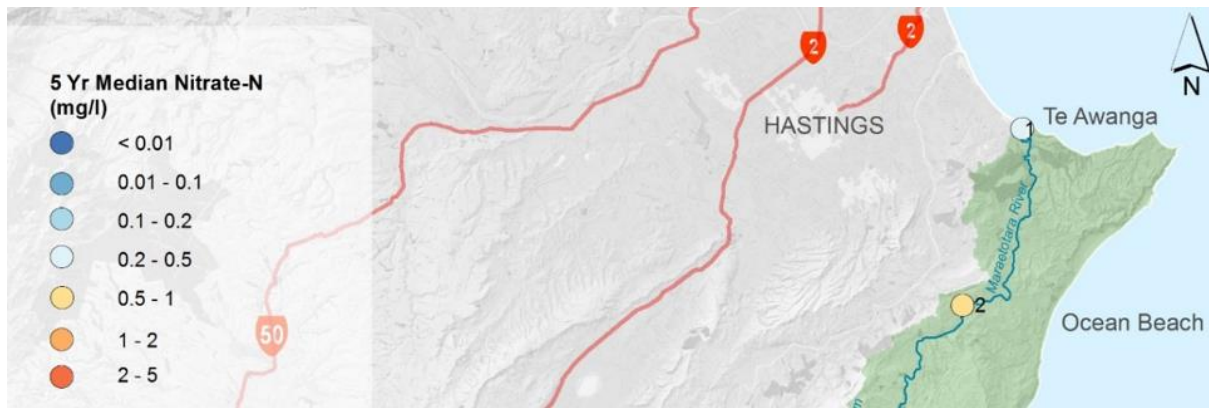
5 year median and trends in nitrate-nitrogen (NO<sub>3</sub>-N) concentrations at SOE monitoring sites

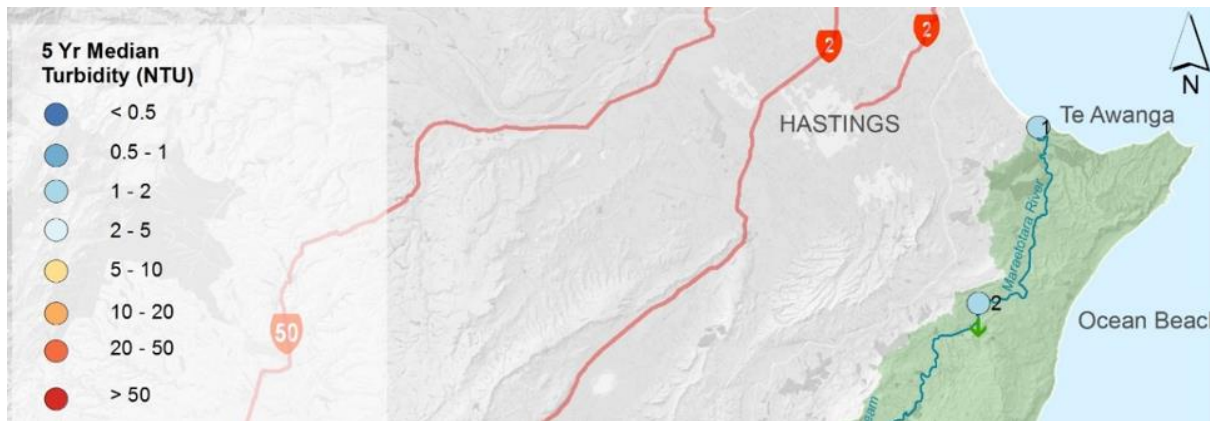
5 year median and trends in Black Disc (BD) water clarity at SOE monitoring sites

Sites on the Maraetōtara River at Waimarama Rd and Te Awanga had median black disc sighting distances of 2.85m and 3.05m respectively, although these are below the recommended minimum 3.5 m for 'significant trout fisheries'. Trend analyses of these SOE monitoring sites shows improvements in median black disc values, with increases of 14.7% and 10.99% at Waimarama Rd and Te Awanga respectively.

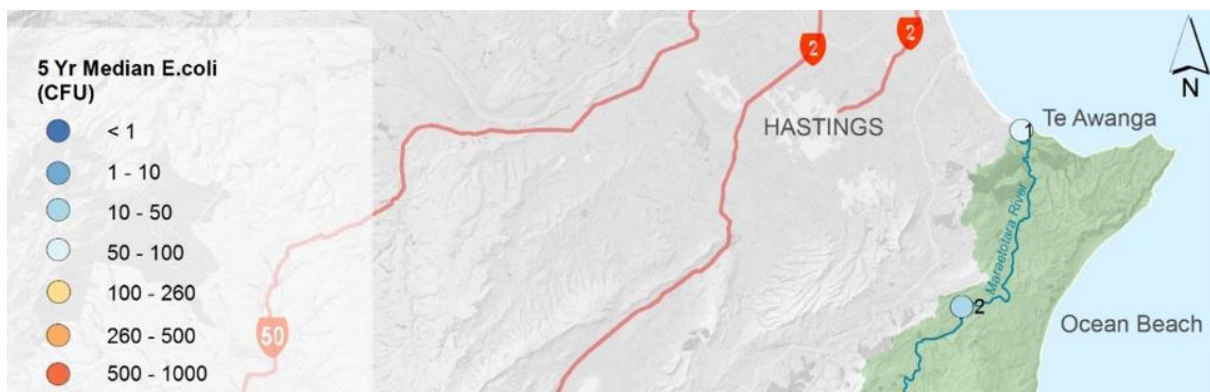
5 year median *E. coli* concentrations at SOE monitoring sites including trend direction.

Escherichia coli (commonly abbreviated as *E. coli*) concentrations have been routinely monitored throughout the Porangahau and Southern catchments as an indicator of microbiological water quality. *E. coli* is a bacterium commonly found in the lower intestine of warm-blooded animals and is an important indicator of the presence of pathogens of faecal origin in the water. *E. coli* is used to assess the level of health risk to water users having direct contact with water. The Maraeotara River (at Waimarama Rd) ranked in the top 40%, of all Hawke's Bay regional sites.

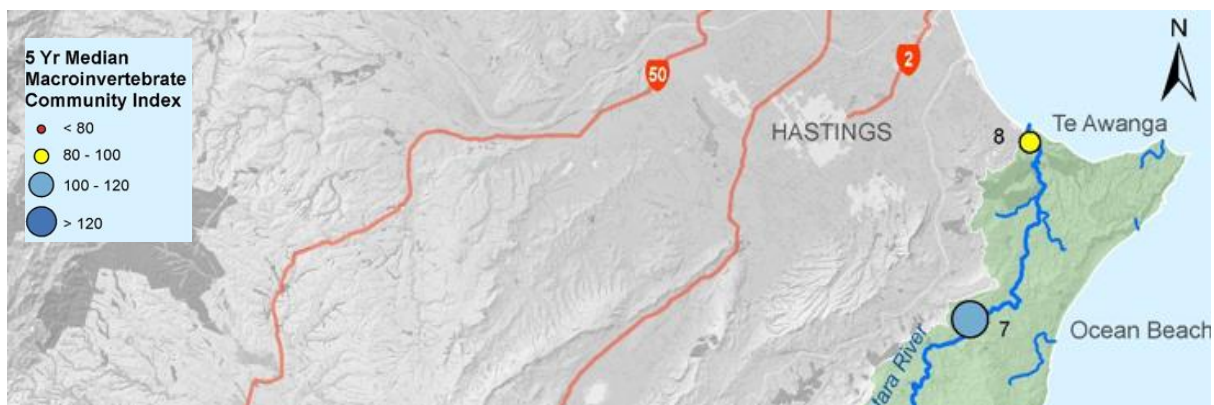
5 year median Macroinvertebrate Community Index (MCI) scores at SOE monitoring sites.

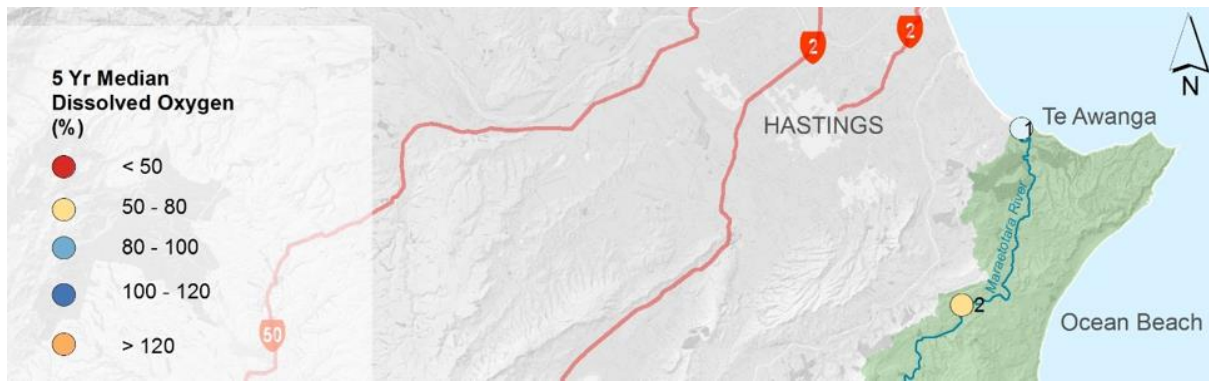
*5 year median dissolved oxygen % saturation levels at SOE monitoring sites*

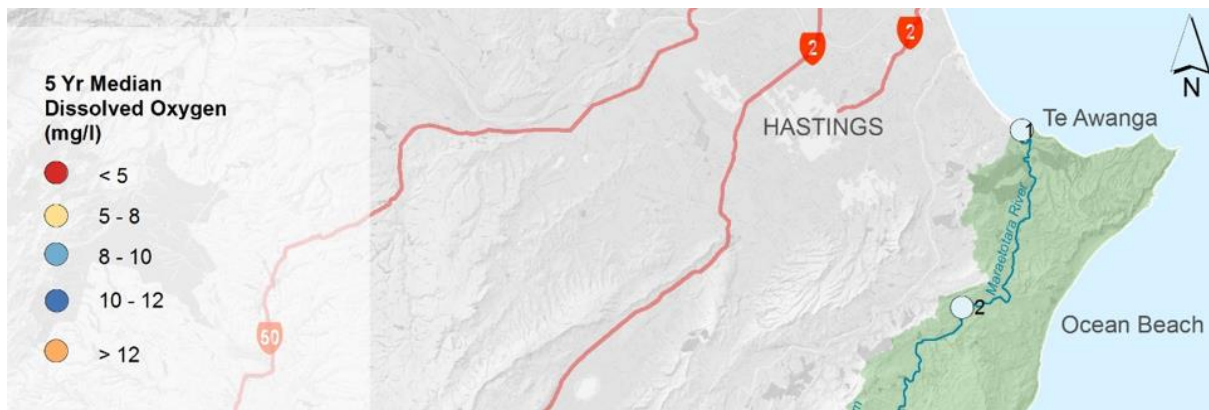
*5 year median dissolved oxygen concentration levels at SOE monitoring sites.*
